# IKEA Canopy Restoration

Summer 2025

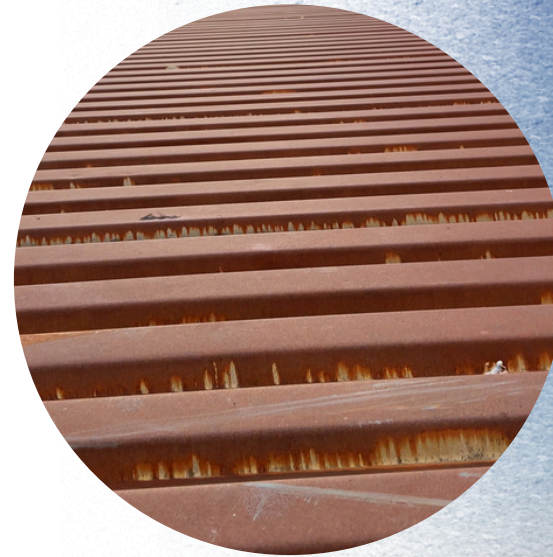
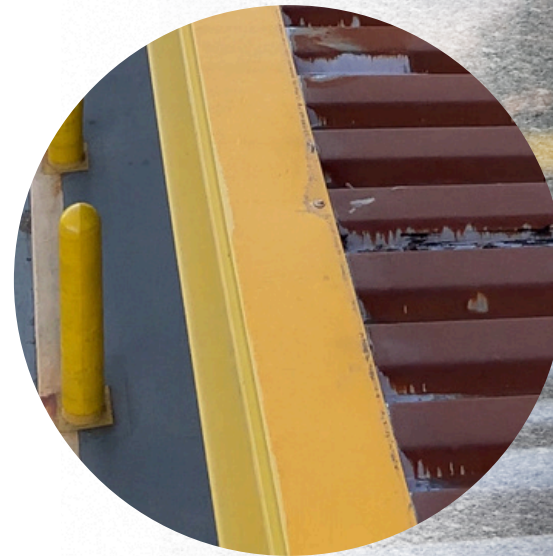
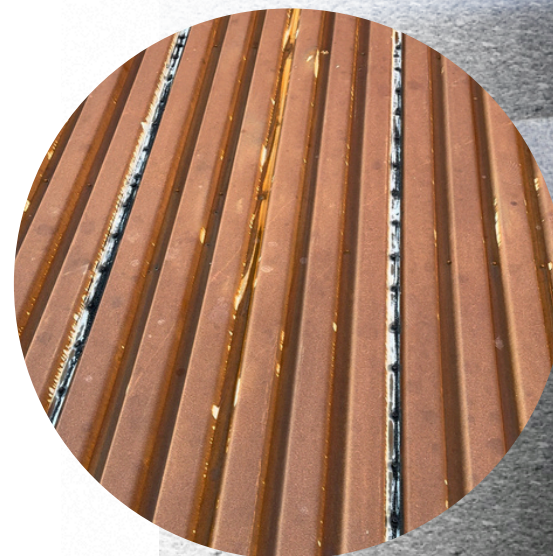
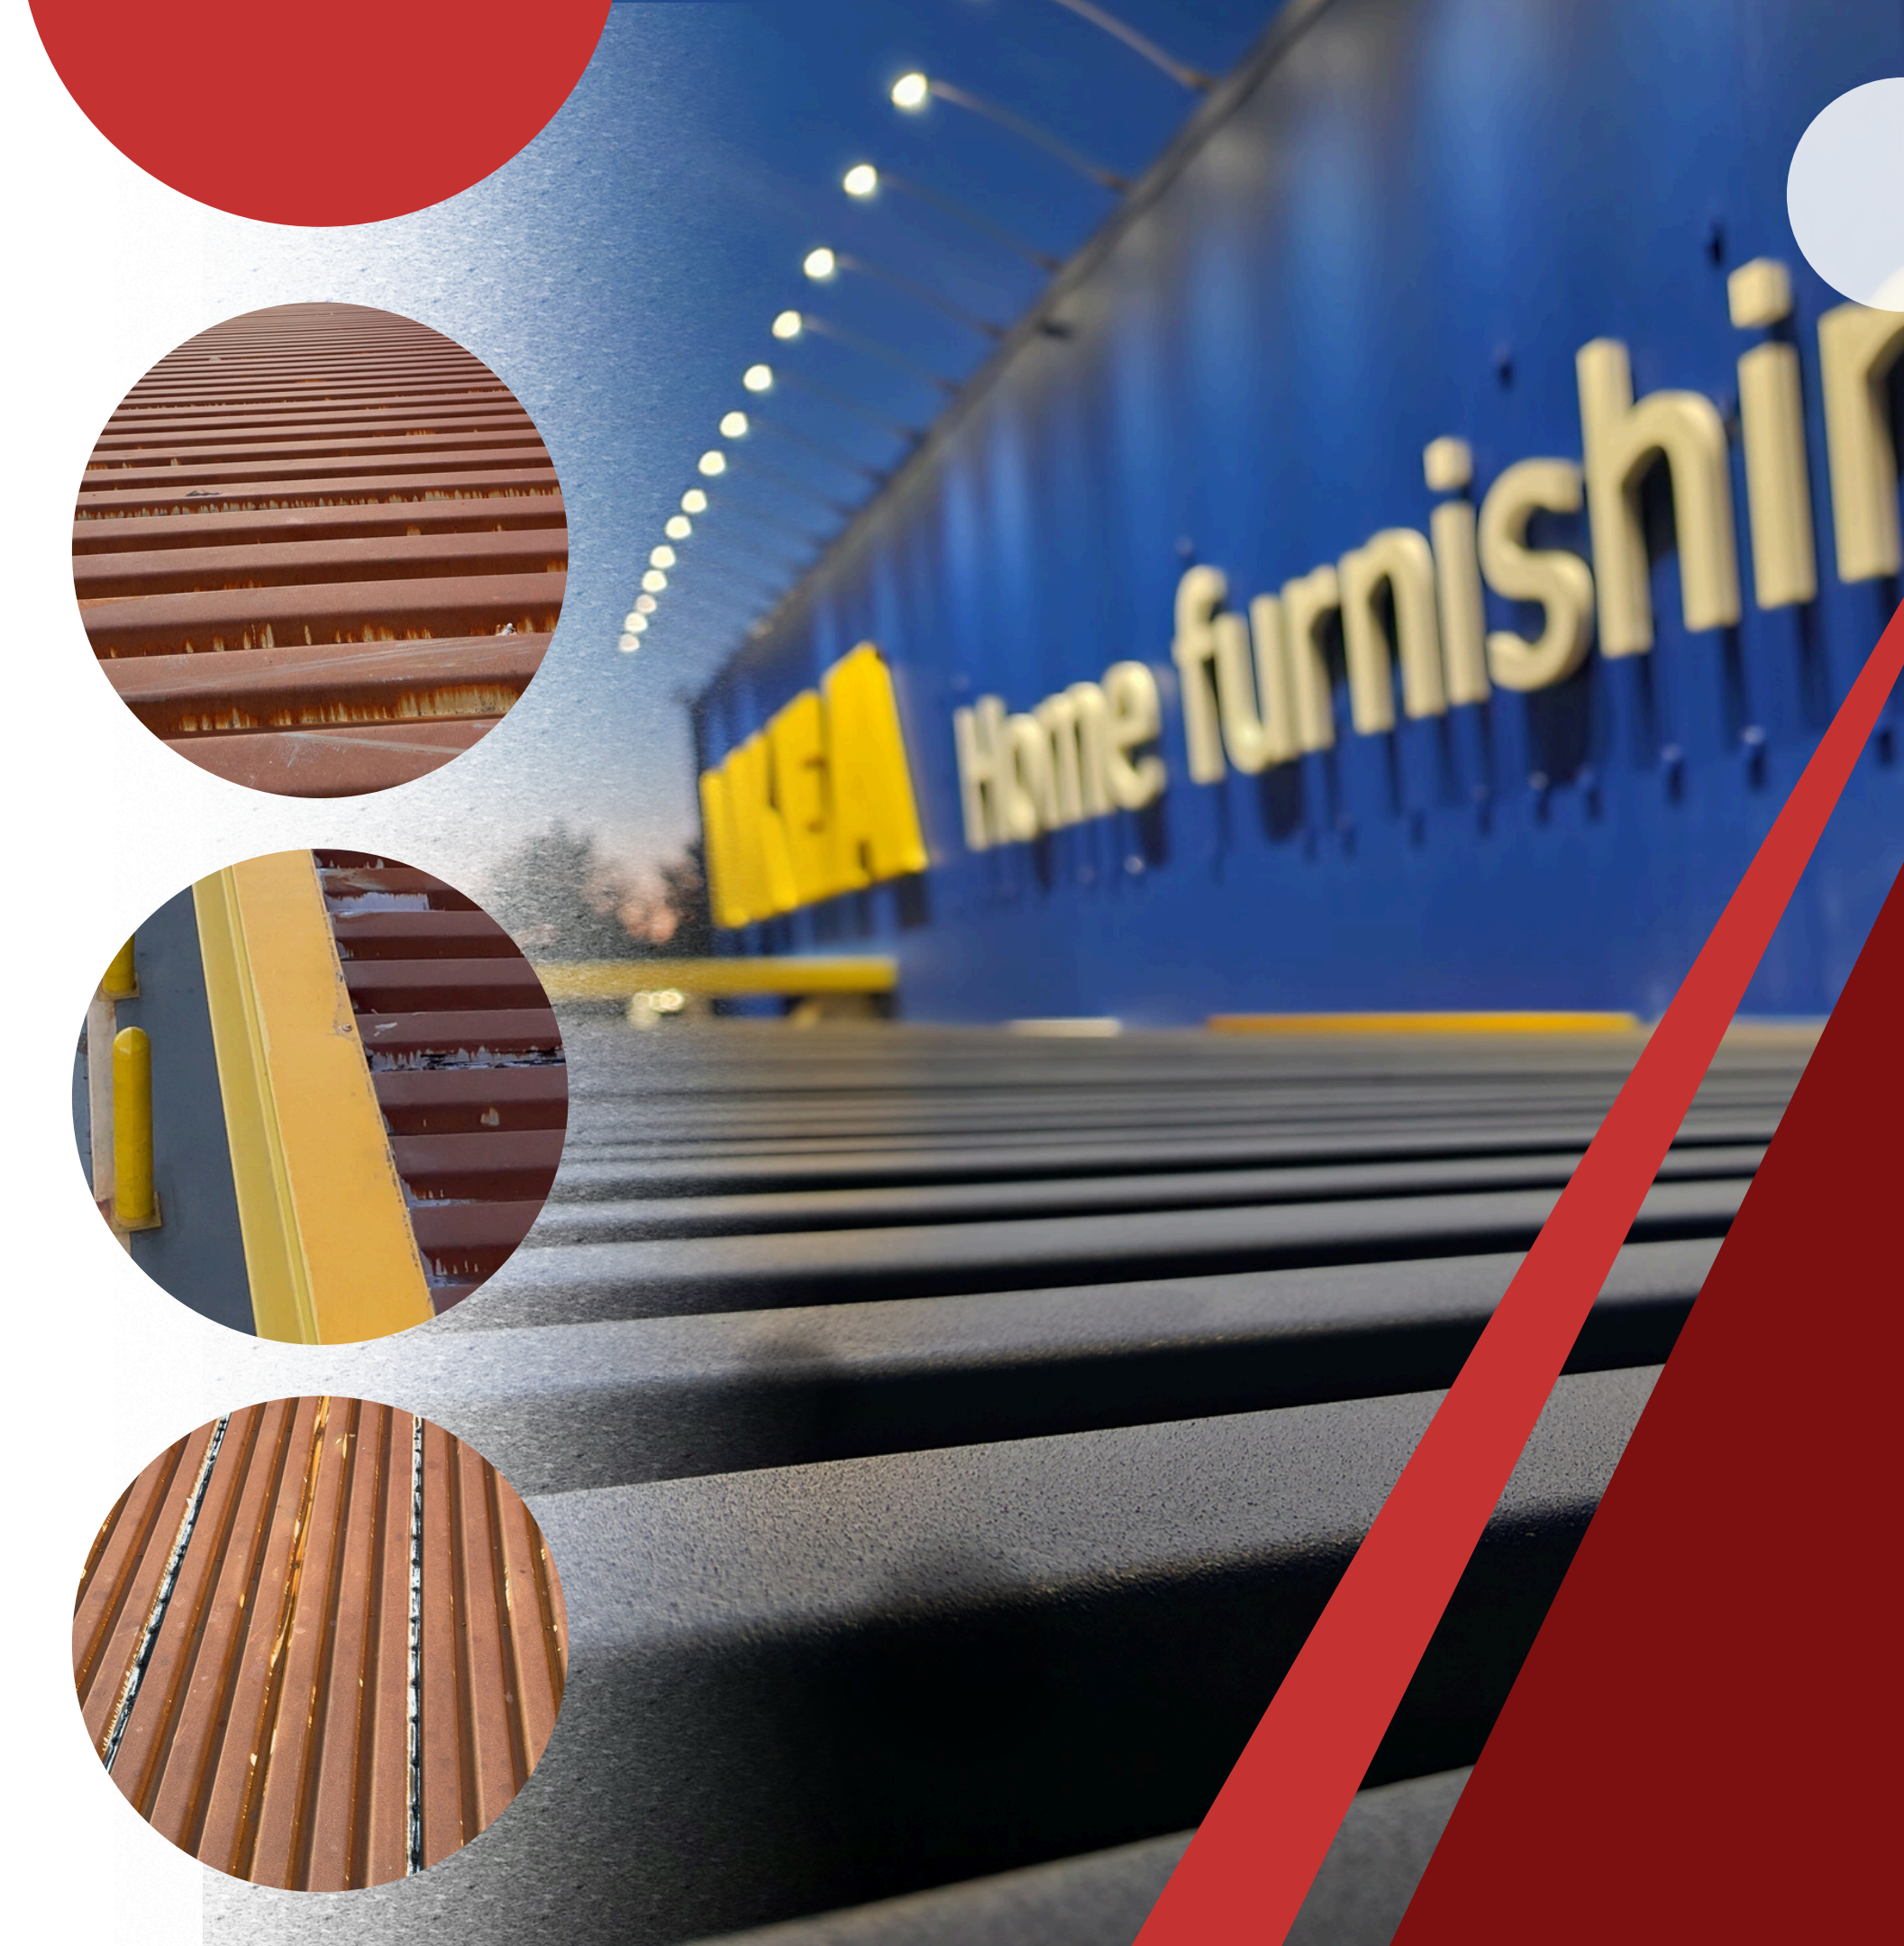
The store's exterior metal canopy, exposed to rain, UV, and temperature fluctuations for years, had developed visible corrosion across large surface areas. The degradation risked both aesthetic appeal and structural integrity.

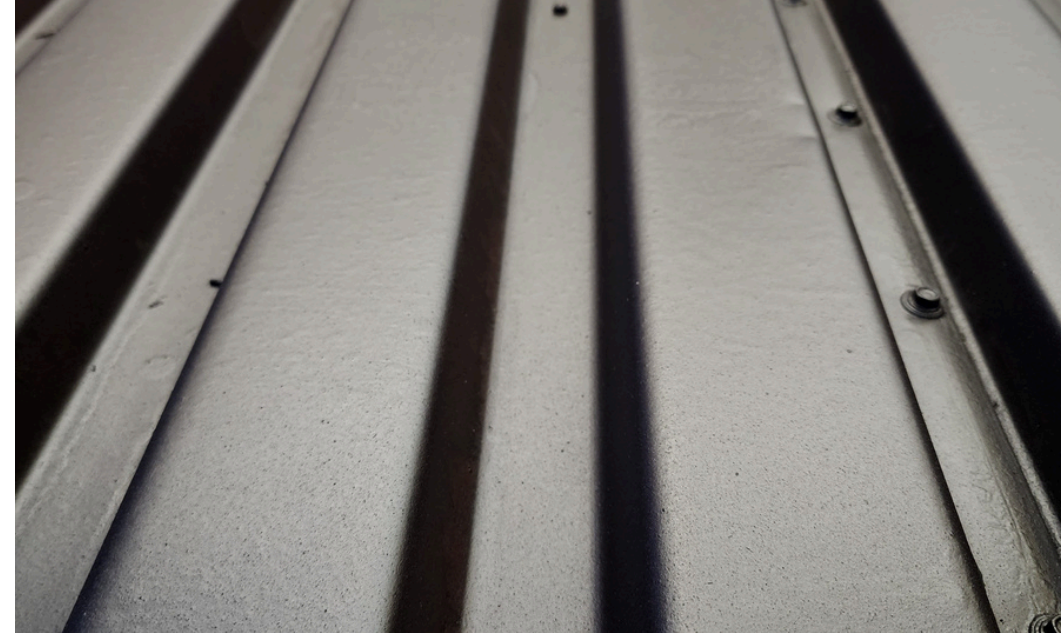
After  
AnarPrime

Two coats of AnarPrime™ were applied directly on the corroded metal to convert rust into a stable, anti-corrosion primer, creating a solid foundation for further coatings.

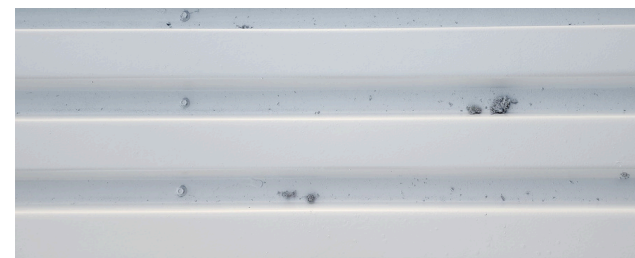
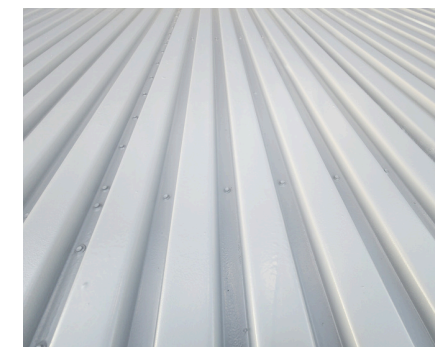
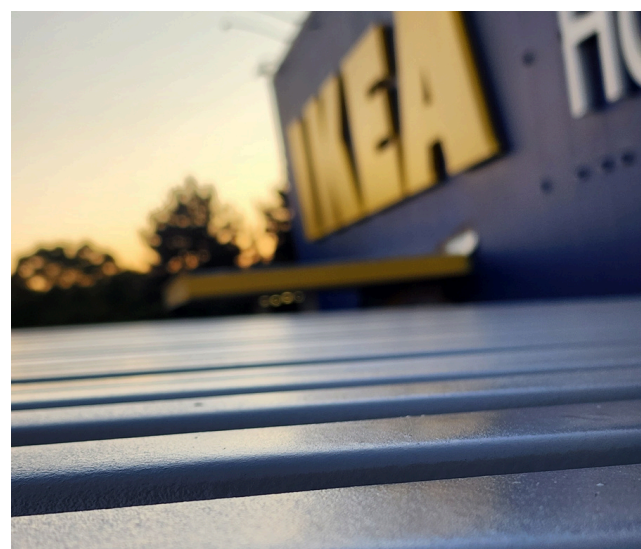
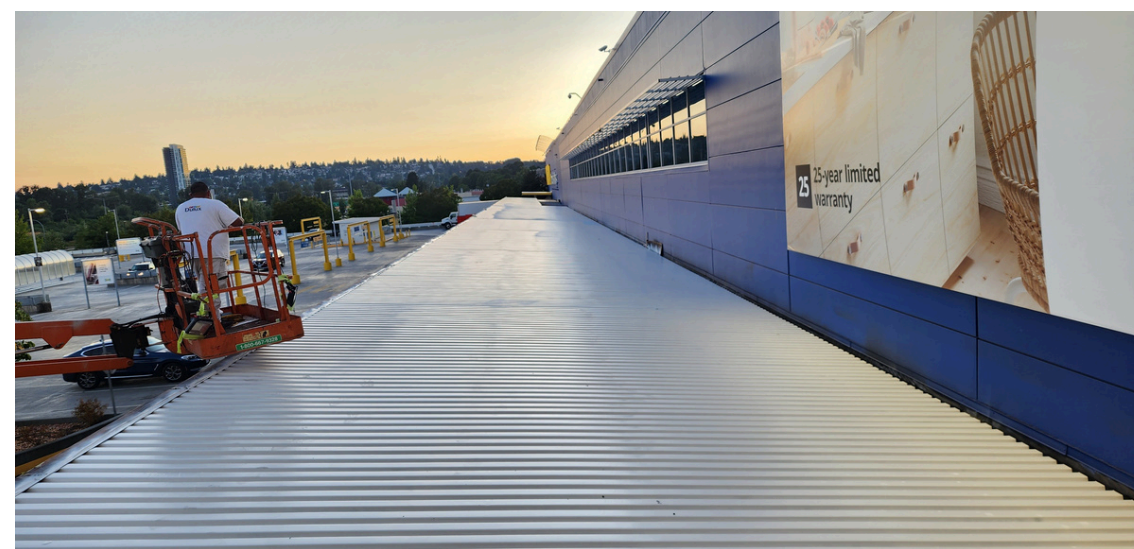
# After Top-coat

A UV-resistant polyurethane topcoat, tinted in IKEA's custom grey, was applied for a cohesive finish and lasting protection against sunlight, rain, and temperature changes.
