Client Profile

IKEA Coquitlam, located at 1000 Lougheed Highway, serves the Metro Vancouver area as one of 16 IKEA stores across Canada. As part of the world's largest furniture retailer, with over 480 stores globally, the Coquitlam location embodies IKEA's core principles not just in its products but also in how it manages its facilities.

Solution

AnarPrime™ was selected to fully restore six main metal staircases, totaling over 2500 sq. ft. This innovative solution was chosen as it directly aligned with IKEA's core values, delivering a safe, sustainable, and aesthetically revitalized result with minimal downtime.

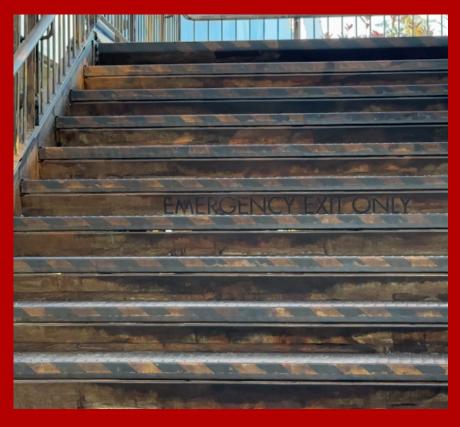
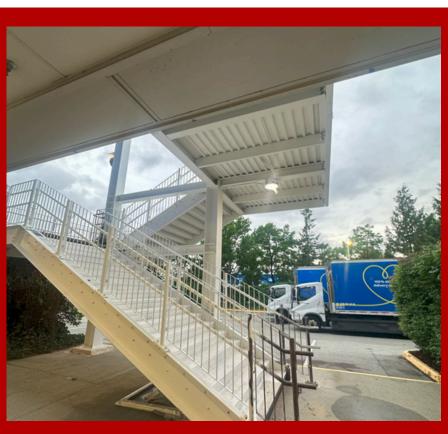
Surface Preperation

Loose flakes and blisters were removed by light wire brushing, followed by a pressure washing to remove contaminants

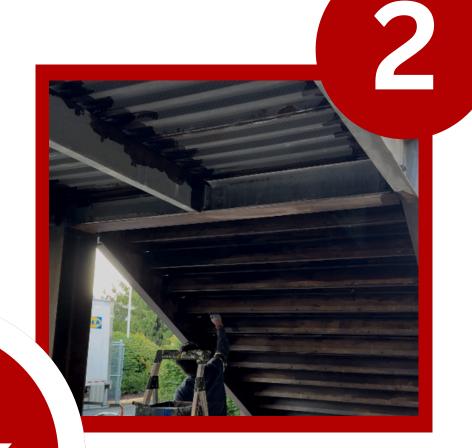
3-in-1 Converter, Primer & Sealer coating

Two coats of Anarprime™ were applied to chemically convert existing rust into a stable, anticorrosion layer, creating a paintable surface and crucial foundation for subsequent coats.

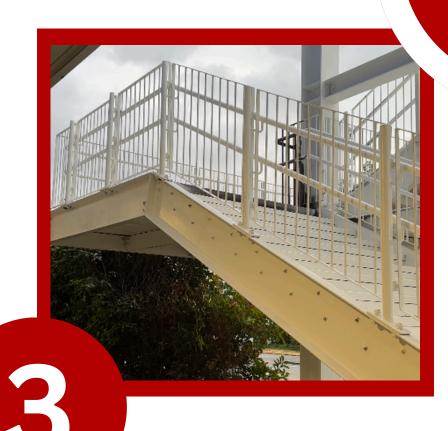
Middle Coat

A Fast Cure, high-solids epoxy coating was applied to enhance chemical and moisture resistance. Its durable formulation creates a tough protective layer that withstands daily foot traffic and mechanical impact, guarding the surface against wear and abrasions
