# REVIVING ASSETS: WASTEWATER TANK RESTORATION

Summer 2025

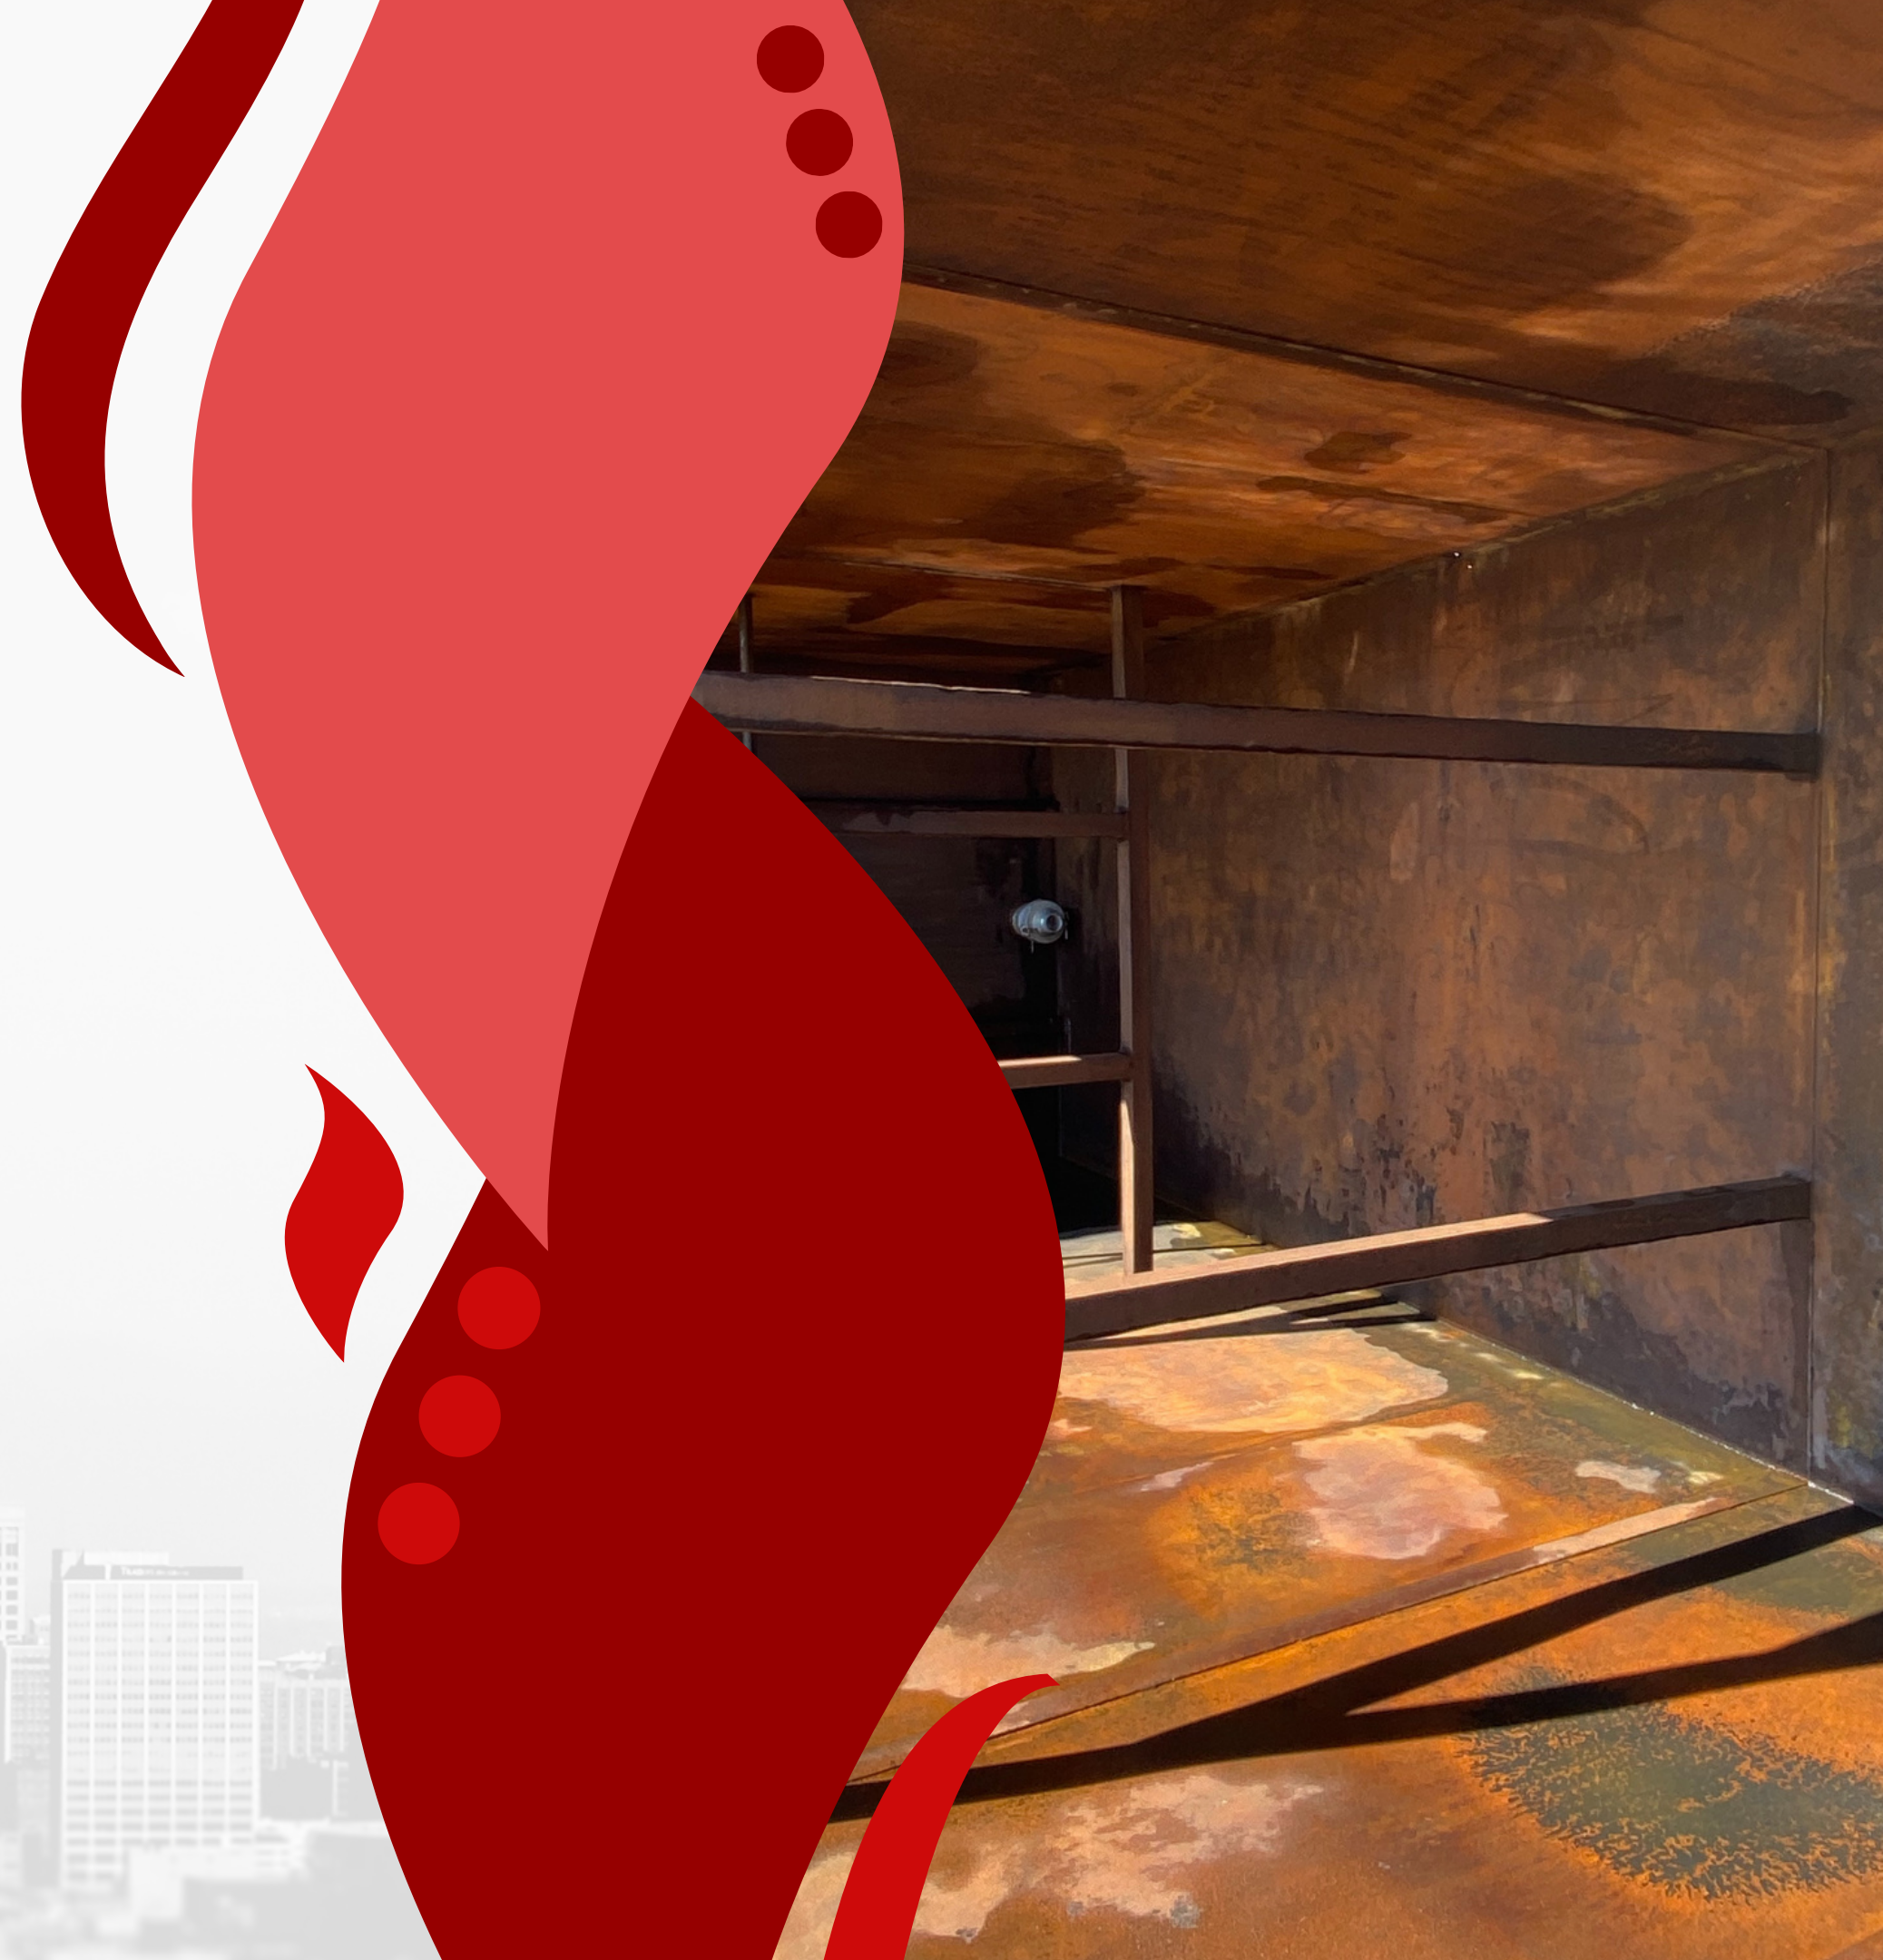
Effective stormwater management is essential in steel recycling, requiring reliable infrastructure. This metal stormwater tank, vital for containing collected rainwater, faced corrosion-induced metal deterioration which could eventually result in significant integrity challenges.

A high-performance, multi-layer coating system featuring AnarPrime™ was chosen to restore the interior of the 20,000-gallon metal stormwater tank. By using this advanced solution, Richmond Steel achieved significant cost savings while extending the asset's service life and avoiding a costly replacement.

The tank's interior was prepared by wire brushing corroded areas to an SSPC-SP3 standard, followed by a thorough power wash. AnarPrime™ was then directly applied to the rusty interior surfaces. A durable epoxy topcoat was then added to create a seamless, protective barrier. This cost-effective restoration was completed in just under a week, significantly extending the tank's service life with minimal operational downtime.

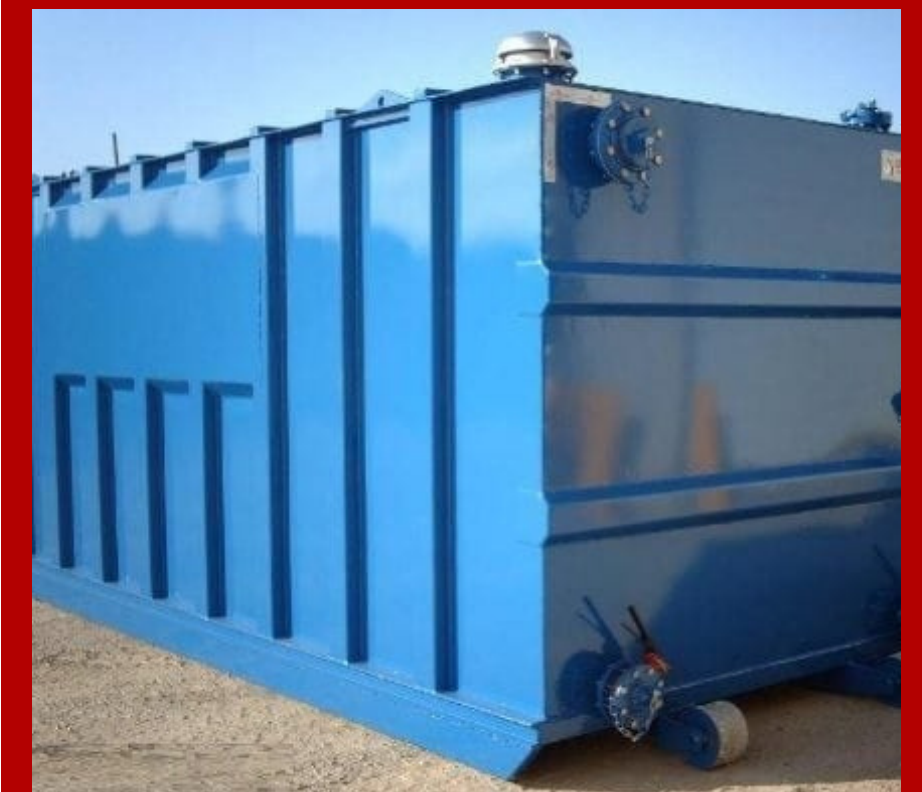
1

## Surface Preperation

Loose flakes and blisters were removed by light wire brushing, followed by a pressure washing to remove contaminants

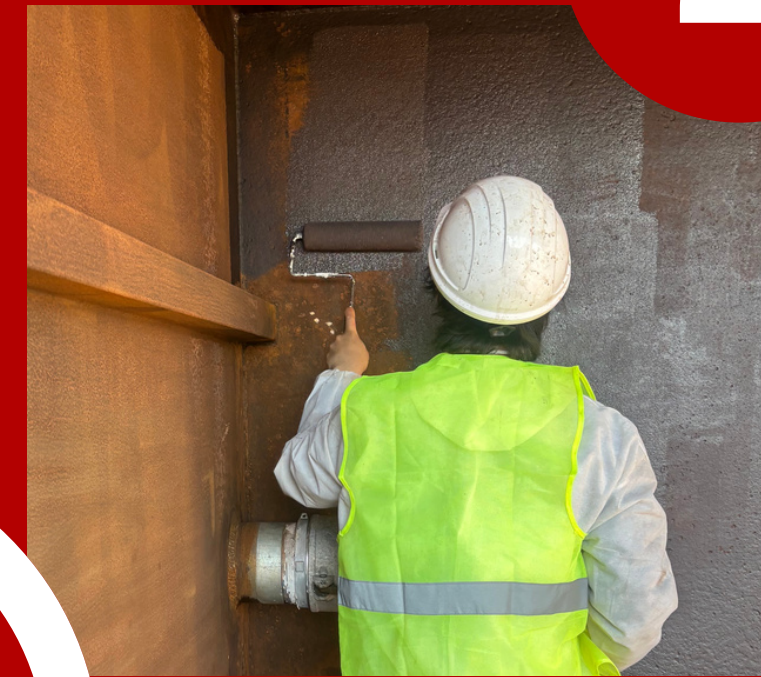
2

## 3-in-1 Converter, Primer & Sealer coating

Two coats of Anarprime™ were applied to chemically convert existing rust into a stable, anti-corrosion layer, creating a paintable surface and crucial foundation for subsequent coats.

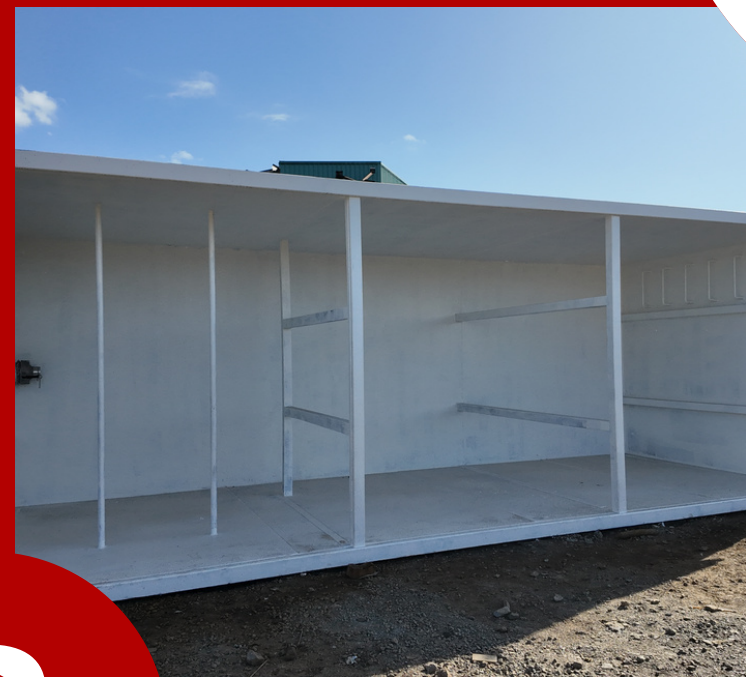
## Middle Coat

A Fast Cure epoxy was applied for enhanced chemical and moisture resistance. This high-solids epoxy provides a strong barrier against the corrosive wastewater environment.

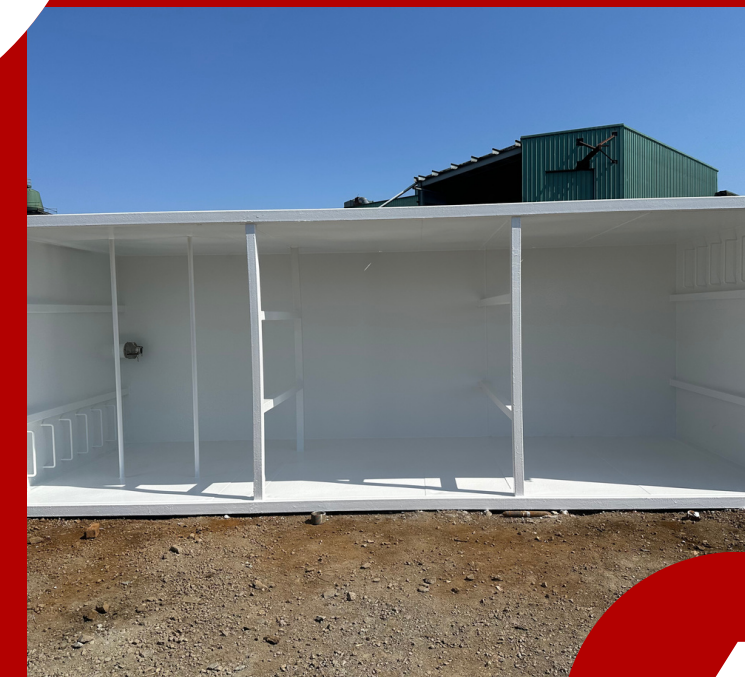
3

## Top Coat

Given the specific application of the tank that required a top coat suitable for immersion applications, a high-performance polysiloxane top coat was applied over the epoxy. This final layer provides enhanced durability and UV protection against the tank's harsh working environment
